ASBESTOS BUILDING INSPECTION REPORT PRE-DEMOLITION BUILDING SURVEY

HRP Associates, Inc.
One Fairchild Square, Suite 110
Clifton Park, New York 12065

CHIPS Friable only
4360 Acme Road
Ilion, New York

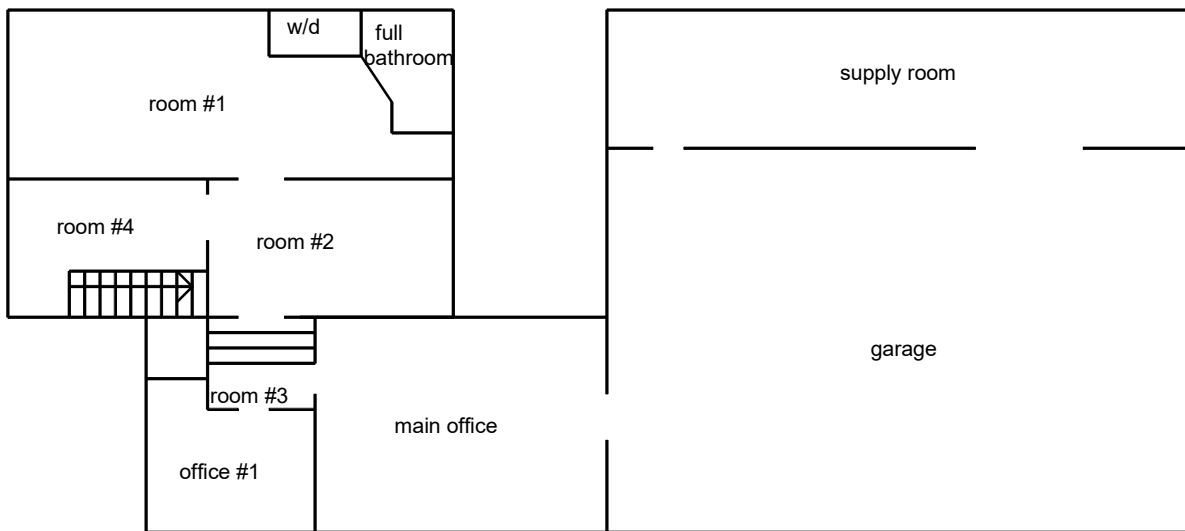
APPENDIX "B" First Floor

All Asbestos shall be removed by an NYS licensed Asbestos Abatement contractor.

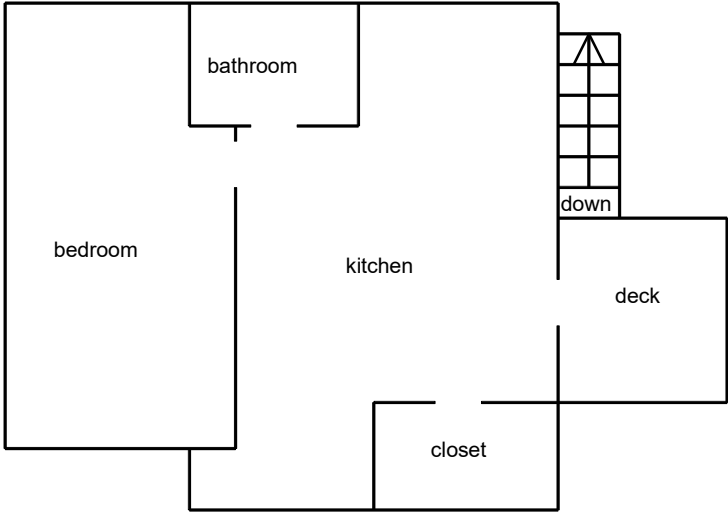
APPENDIX "B" Second Floor

All Asbestos shall be removed by an NYS licensed Asbestos Abatement contractor.

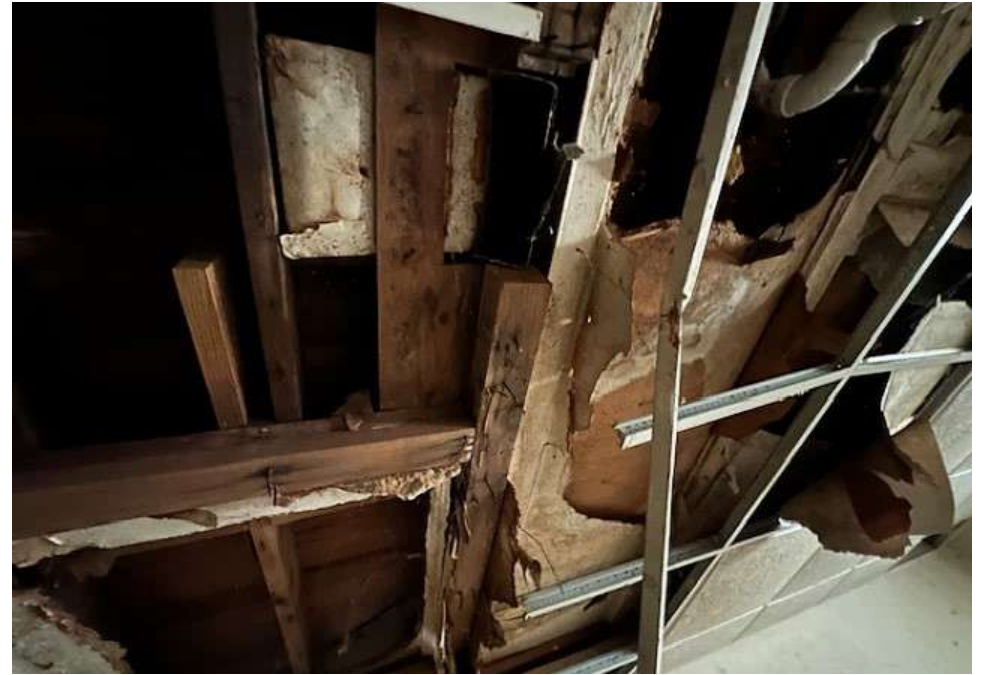
room #1 - duct wrap

Client No. / HGA	Lab No.	Asbestos Present	Total % Asbestos
01-1A 1	224033177-01 Location: 1st Floor Room #1, Heat Duct - Duct Wrap	Yes	57.1% (by NYS ELAP 198.1) by Valeriu Voicu on 04/01/24
Analyst Description: Gray, Homogeneous, Fibrous, Bulk Material Asbestos Types: Chrysotile 57.1 % Other Material: Non-fibrous 42.9%			
02-1B 1	224033177-02 Location: 1st Floor Room #1, Heat Duct - Duct Wrap		NA/PS
Analyst Description: Bulk Material Asbestos Types: Other Material:			
03-2A 2	224033177-03L1 Location: 1st Floor Room #1 - Joint Compound, Joint Tape And Drywall / Joint Compound	No	NAD (by NYS ELAP 198.1) by Valeriu Voicu on 04/01/24
Analyst Description: White, Homogeneous, Non-Fibrous, Bulk Material Asbestos Types: Other Material: Cellulose Trace, Non-fibrous 100%			
03-2A 2	224033177-03L2 Location: 1st Floor Room #1 - Joint Compound, Joint Tape And Drywall / Joint Tape	No	NAD (by NYS ELAP 198.1) by Valeriu Voicu on 04/01/24

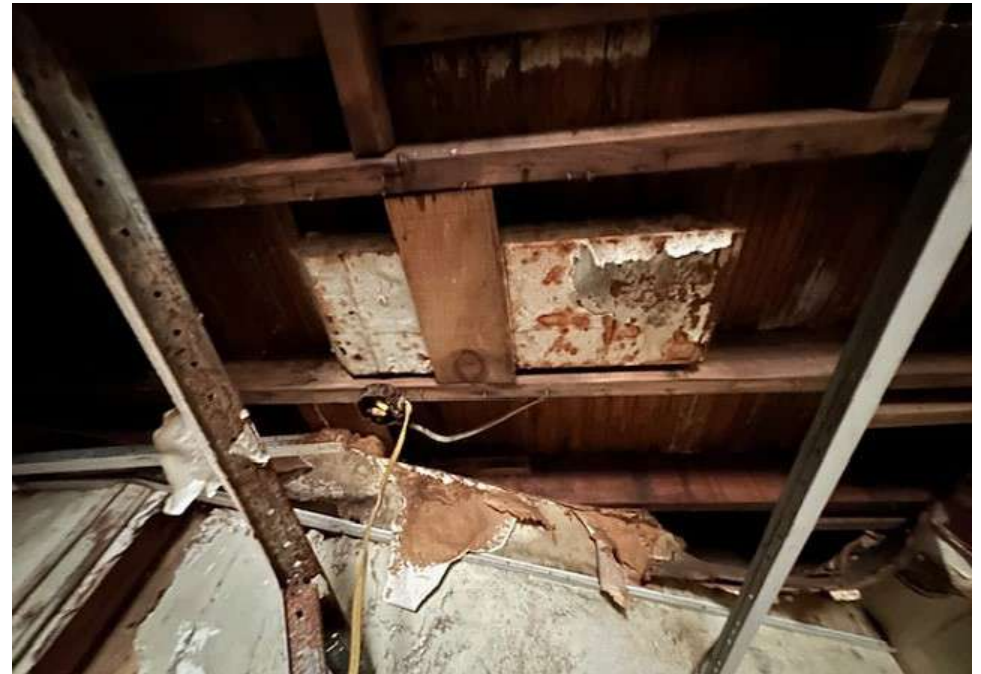
room #1 - duct wrap

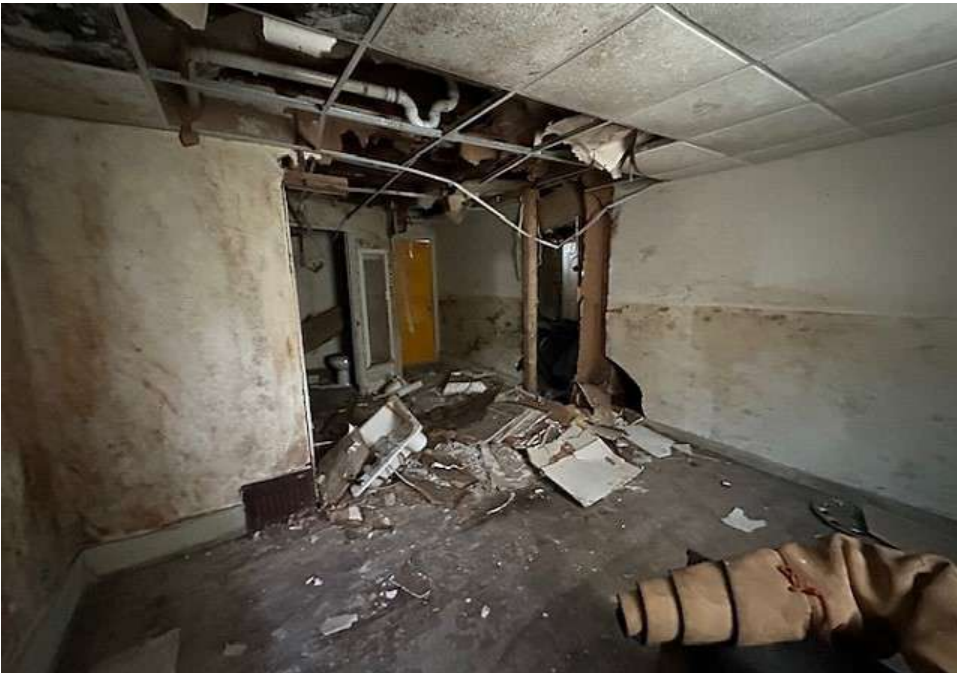
room #1 - debris pile

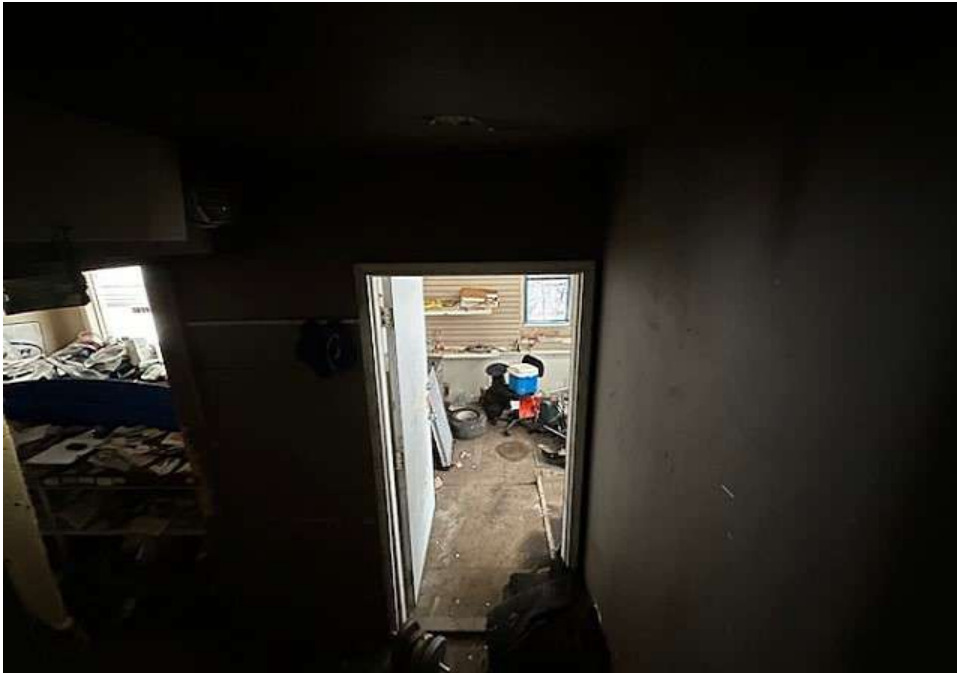
room #3

Client No. / HGA	Lab No.	Asbestos Present	Total % Asbestos
09-5A 5	224033177-09L2 Location: 1st Floor Room #3 - Joint Compound, Joint Tape And Drywall / Tape	Yes	Trace (<0.25 % pc) (ELAP 400 PC) by Valeriu Voicu on 04/01/24
Analyst Description: Beige, Homogeneous, Fibrous, Bulk Material Asbestos Types: Chrysotile <0.25 % pc Other Material: Cellulose 90%, Non-fibrous 10%			
09-5A 5	224033177-09L3 Location: 1st Floor Room #3 - Joint Compound, Joint Tape And Drywall / Drywall	No	NAD (by NYS ELAP 198.1) by Valeriu Voicu on 04/01/24
Analyst Description: Off-White/Brown, Heterogeneous, Fibrous, Bulk Material Asbestos Types: Other Material: Cellulose 20%, Non-fibrous 80%			
10-5B 5	224033177-10L1 Location: 1st Floor Room #3 - Joint Compound, Joint Tape And Drywall / Joint Compound		NA/PS
Analyst Description: Bulk Material Asbestos Types: Other Material:			
10-5B 5	224033177-10L2 Location: 1st Floor Room #3 - Joint Compound, Joint Tape And Drywall / Tape	Yes	Trace (<0.25 % pc) (ELAP 400 PC) by Valeriu Voicu on 04/01/24

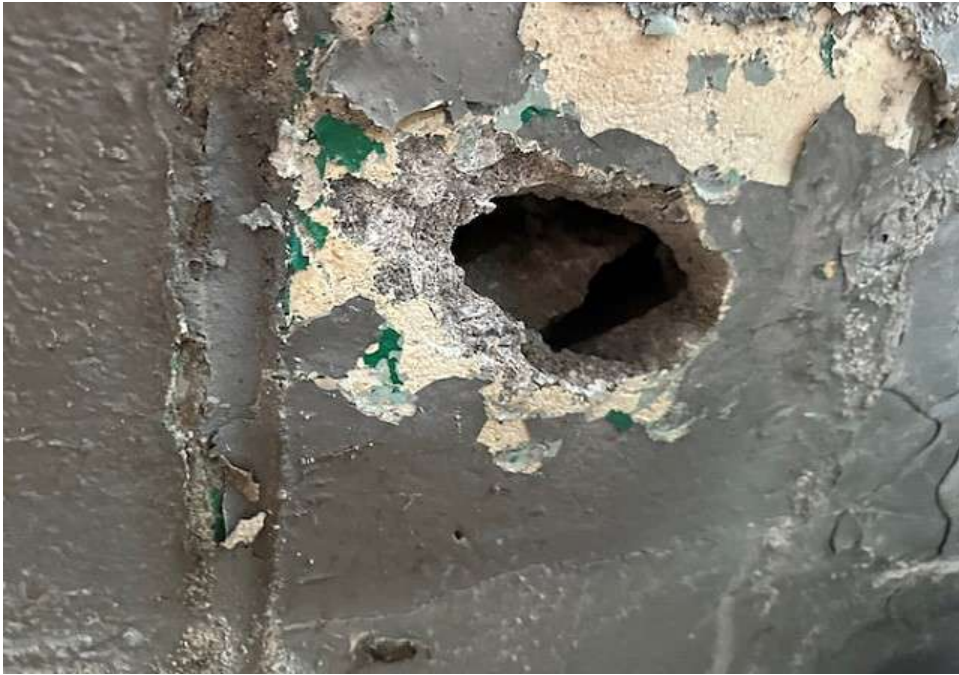
Garage wall - no vermiculite

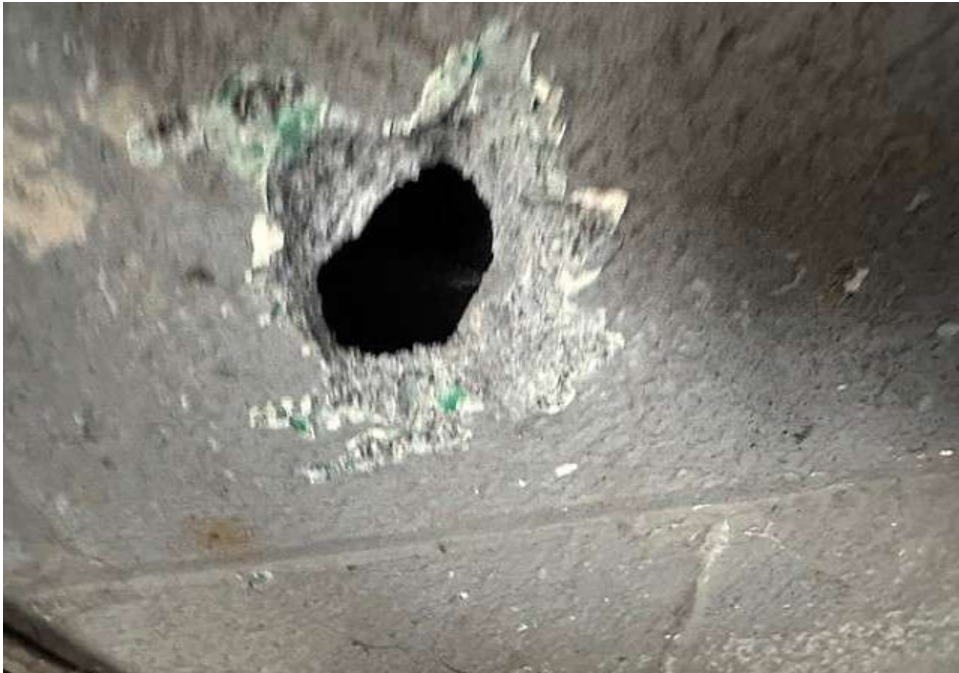
Garage wall - no vermiculite
