REMEDIAL ACTION WORKPLAN

Former Chip's Service Station

4360 Acme Road
Frankfort, New York

RE: REPORT OF ASBESTOS SURVEY, FORMER CHIP'S SERVICE STATION, 4360 ACME ROAD, FRANKFORT, NEW YORK (HRP PROJECT HER1513.BA)

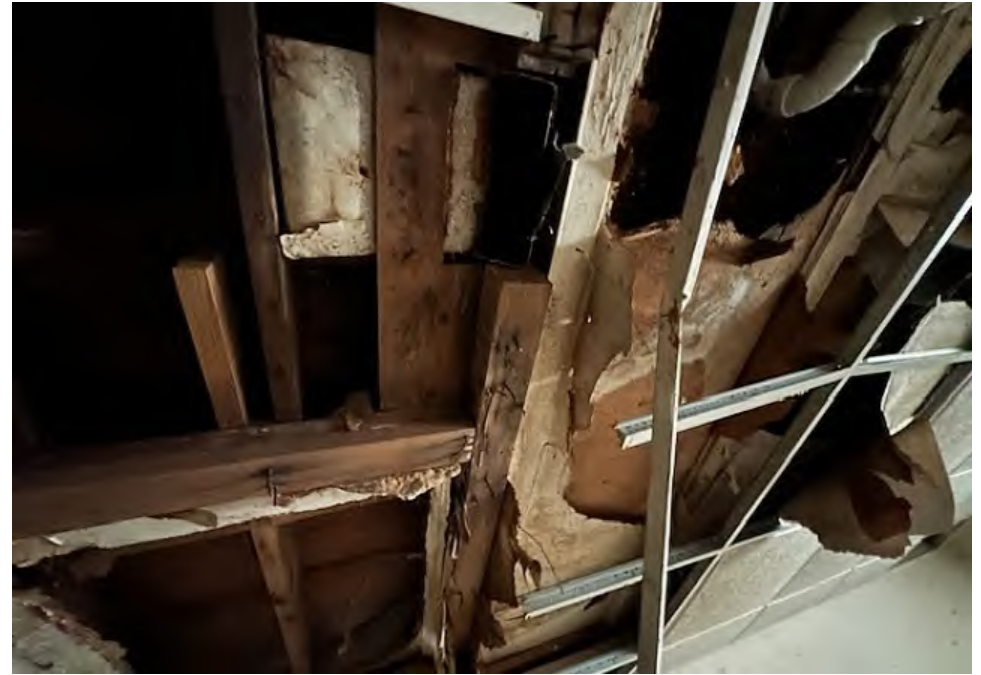
01-1a	duct wrap is significantly damaged and has fallen into the pile	of debri on the floor.

room #1 - duct wrap

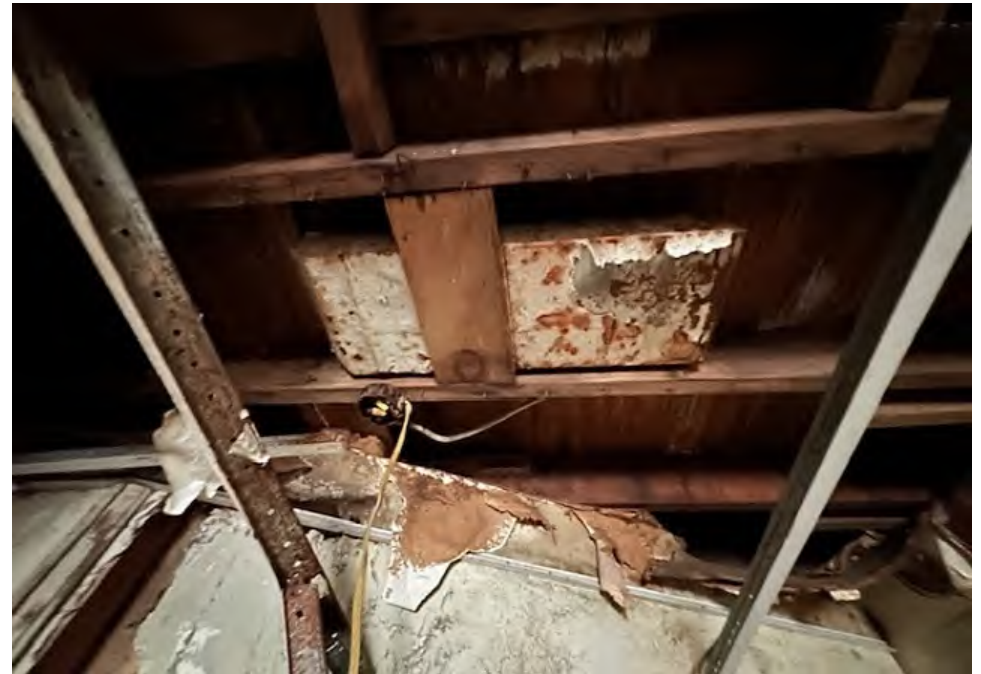
room #1 - duct wrap

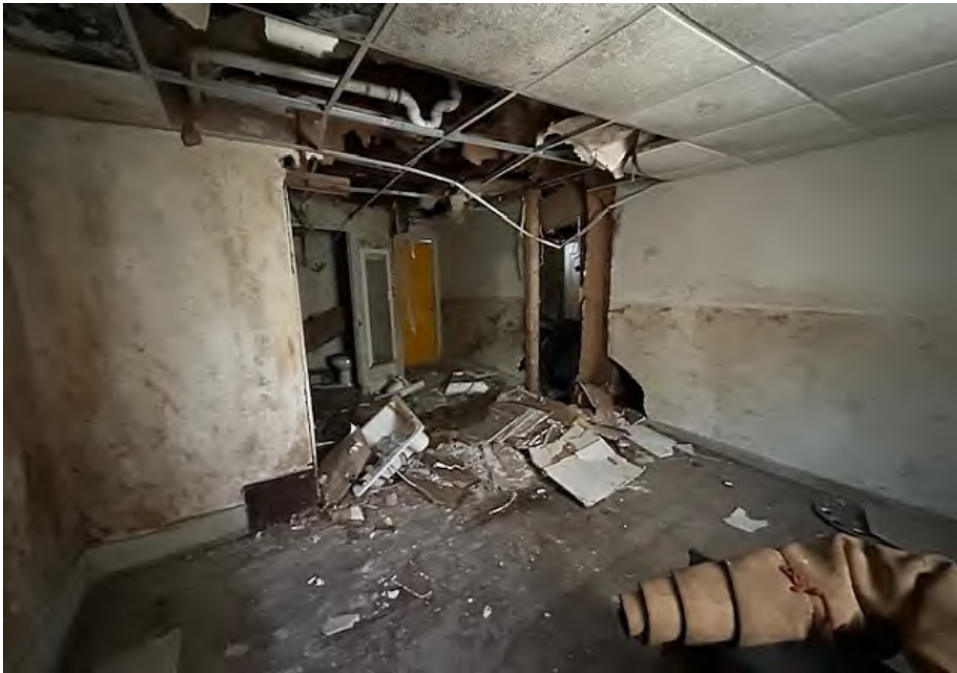
room #1 - debris pile

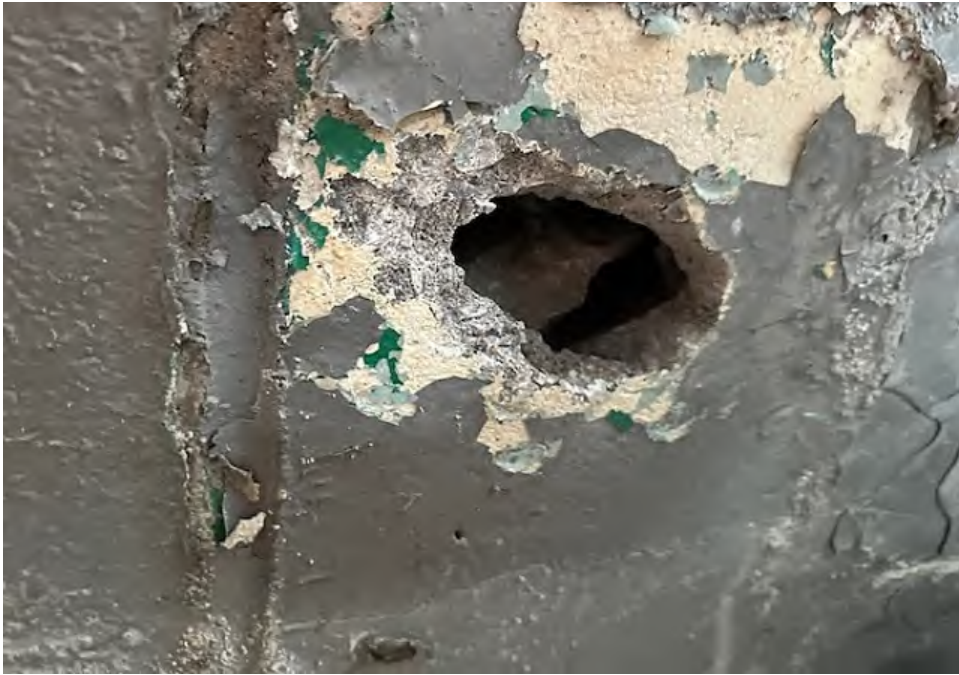
Garage wall - no vermiculite

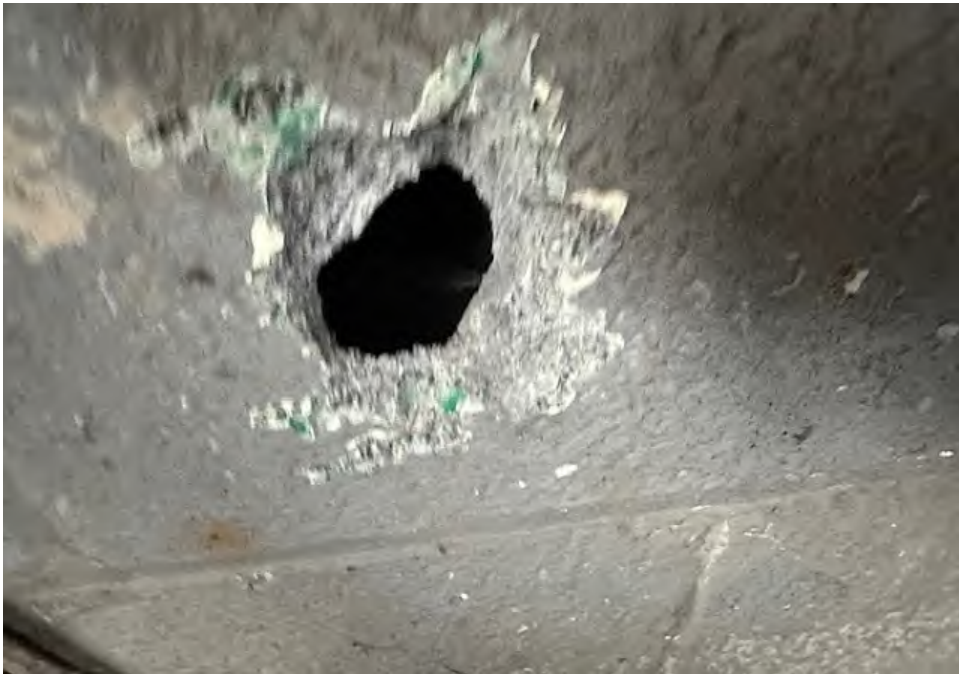
Garage wall - no vermiculite
